INSTALLATION RESTORATION PROGRAM

PHASE I - RECORDS SEARCH

AIR FORCE PLANTS NOS. 28 AND 29 EVERETT AND LYNN, MA

June 1984

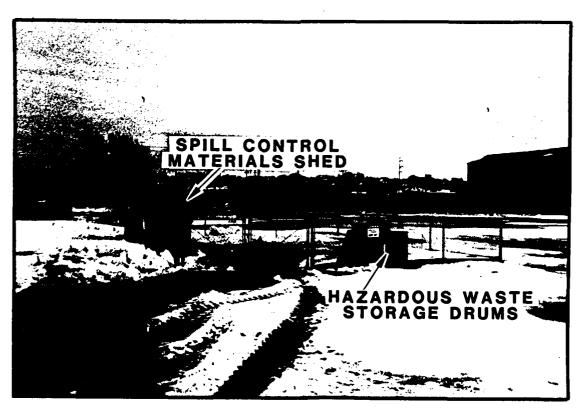
Hazardous Waste Storage Area and Shed
